MANAGEMENT SURVEY FOR ASBESTOS-CONTAINING MATERIALS

CLIENT: University of Gloucestershire

SITE: Administration centre, Hardwick Campus, St. Pauls Road, Cheltenham, Gloucestershire, GL50 4BS

TYPE OF SURVEY: Management Survey

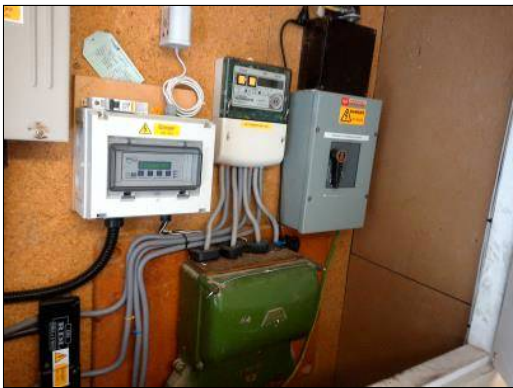
Assessment details				Comments	Photograph
Building	Administration Centre	Floor/ room	Ground Floor / 001 Lobby	No access to electrics throughout - live services

Assessment no.	001	Accessibility			
Material Risk					
Identification	Inaccessible (Presumed)	Condition	n/a		
Extent		Asbestos Type	n/a		
Location/ position	No access to electrics throughout				
Surface treatment	n/a				
Product type	n/a				
Material risk		Material risk score			
Action	Inspect Prior to Disturbance

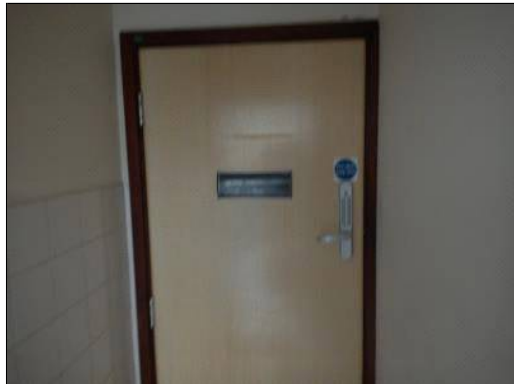
Assessment details				Comments	Photograph
Building	Administration Centre	Floor/ room	Ground Floor / 005 Post room	No access - locked, no key code available at time of survey

Assessment no.	002	Accessibility			
Material Risk					
Identification	Inaccessible (Presumed)	Condition	n/a		
Extent		Asbestos Type	n/a		
Location/ position	No access				
Surface treatment	n/a				
Product type	n/a				
Material risk		Material risk score			
Action	Inspect Prior to Disturbance

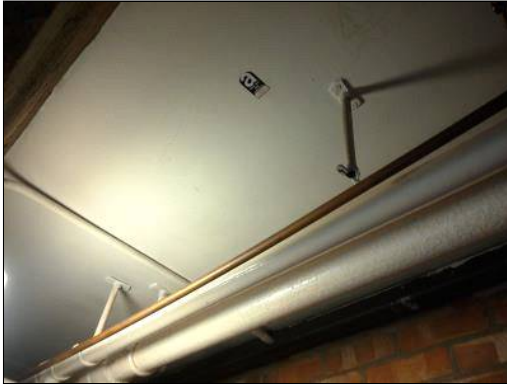
Assessment details				Comments	Photograph
Building	Administration Centre	Floor/ room	Ground Floor / 020 Art room	Already labelled as an ACM

Assessment no.	003	Accessibility	Usually inaccessible or unlikely to be disturbed		
Material Risk					
Identification	Presumed	Condition	Good Condition		
Extent	3m²	Asbestos Type	Crocidolite (or unknown)		
Location/ position	Insulating board Store 1 Ceiling panels				
Surface treatment	Surface Sealed				
Product type	Board				
Material risk	Low	Material risk score	6		
Action	Manage

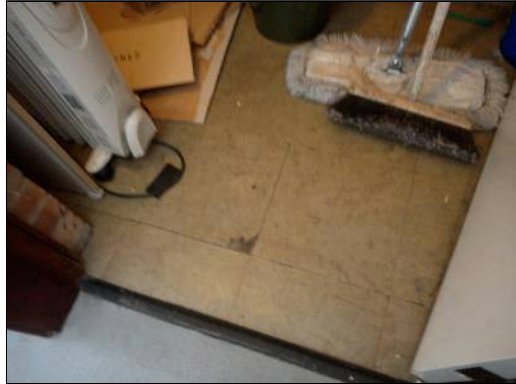
Building	Administration Centre	Floor/ room	Ground Floor / 020 Art room		
Assessment no.	004	Accessibility			
Material Risk					
Identification	Identified	Condition			
Extent		Asbestos Type	No Asbestos Detected		
Location/ position	Vinyl tiles store 1 floor				
Surface treatment					
Product type	n/a				
Material risk		Material risk score			
Action	No further action required

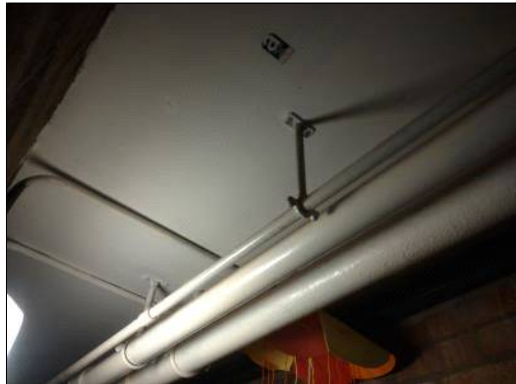
Assessment details				Comments	Photograph
Building	Administration Centre	Floor/ room	Ground Floor / 020 Art room	Already labelled as an ACM

Assessment no.	005	Accessibility	Usually inaccessible or unlikely to be disturbed		
Material Risk					
Identification	Presumed	Condition	Good Condition		
Extent	2m²	Asbestos Type	Crocidolite (or unknown)		
Location/ position	Insulating board Store 2 ceiling panels				
Surface treatment	Surface Sealed				
Product type	Board				
Material risk	Low	Material risk score	6		
Action	Manage

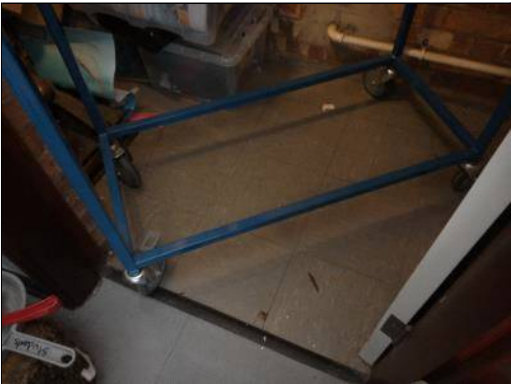
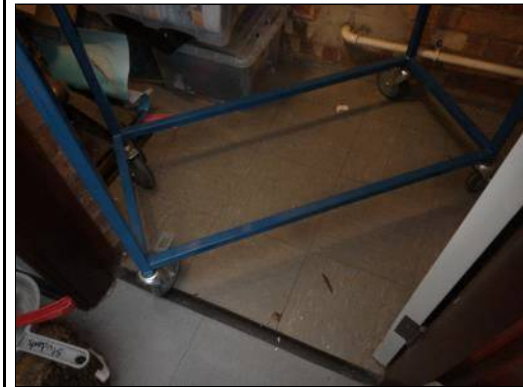
</div>
Building	Administration Centre	Floor/ room	Ground Floor / 020 Art room		
Assessment no.	006	Accessibility	Usually inaccessible or unlikely to be disturbed		
Material Risk					
Identification	Identified	Condition	Good Condition		
Extent	3m²	Asbestos Type	Chrysotile		
Location/ position	Vinyl tiles store 2 floor				
Surface treatment	Completely Sealed				
Product type	Vinyl Floor Tiles				
Material risk	Very low	Material risk score	2		
Action	Manage

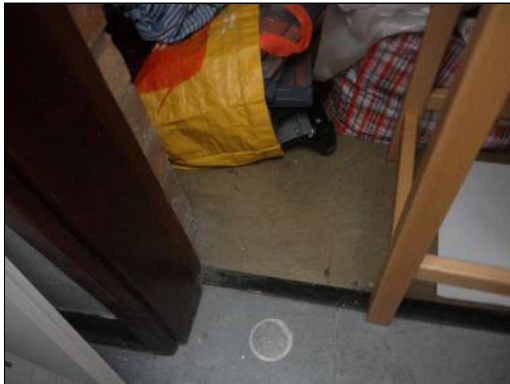
Assessment details				Comments	Photograph	
Building	Administration Centre	Floor/ room	Ground Floor / 020A Art room			
Assessment no.	008	Accessibility				
Material Risk

Identification	Strongly Presumed	Condition				
Extent		Asbestos Type	No Asbestos Detected			
Location/ position	Vinyl tiles Store 1 floor					
Surface treatment						
Product type	n/a					
Material risk		Material risk score				
Action	No further action required

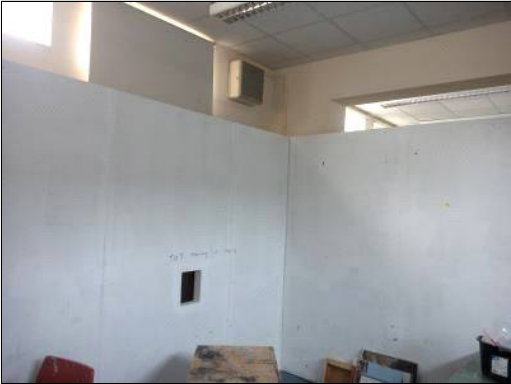
Assessment details				Comments	Photograph
Building	Administration Centre	Floor/ room	Ground Floor / 019 Art studio	Unable to access store cupboards due to timber partitions. Presumed to remain

Assessment no.	009	Accessibility	Usually inaccessible or unlikely to be disturbed		
Material Risk					
Identification	Presumed	Condition	Good Condition		
Extent	6m²	Asbestos Type	Crocidolite (or unknown)		
Location/ position	Insulating board Store 1 and 2 ceiling panels				
Surface treatment	Surface Sealed				
Product type	Board				
Material risk	Low	Material risk score	6		
Action	Manage

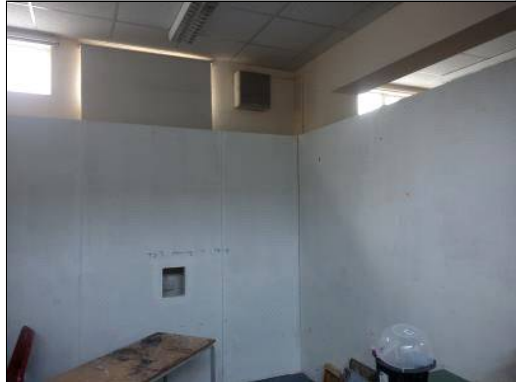
Assessment details				Comments	Photograph
Building	Administration Centre	Floor/ room	Ground Floor / 019 Art studio	Unable to access store cupboards due to timber partitions. Presumed to remain

Assessment no.	010	Accessibility			
Material Risk					
Identification	Strongly Presumed	Condition			
Extent		Asbestos Type	No Asbestos Detected		
Location/ position	Vinyl tiles Store 1 and 2 floors				
Surface treatment					
Product type	n/a				
Material risk		Material risk score			
Action	No further action required

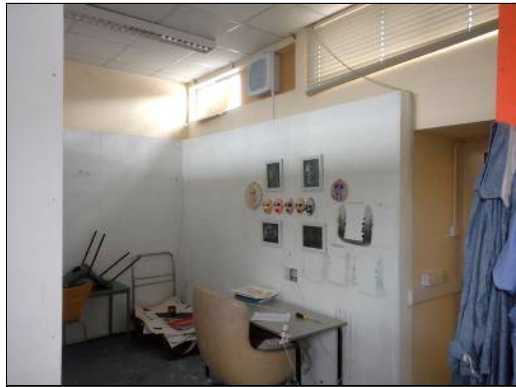
Assessment details				Comments	Photograph
Building	Administration Centre	Floor/ room	Ground Floor / 011 Art studio	Unable to access store cupboards due to timber partitions. Presumed to remain

Assessment no.	011	Accessibility	Usually inaccessible or unlikely to be disturbed		
Material Risk					
Identification	Presumed	Condition	Good Condition		
Extent	9m²	Asbestos Type	Crocidolite (or unknown)		
Location/ position	Insulating board Stores 1, 2 and 3 ceiling panels				
Surface treatment	Surface Sealed				
Product type	Board				
Material risk	Low	Material risk score	6		
Action	Manage

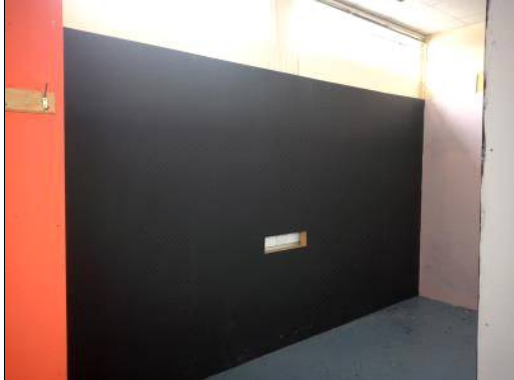
Assessment details				Comments	Photograph
Building	Administration Centre	Floor/ room	Ground Floor / 011 Art studio	Unable to access store cupboards due to timber partitions. Presumed to remain

Assessment no.	012	Accessibility			
Material Risk					
Identification	Strongly Presumed	Condition			
Extent		Asbestos Type	No Asbestos Detected		
Location/ position	Vinyl tiles Stores 1, 2 and 3 floors				
Surface treatment					
Product type	n/a				
Material risk		Material risk score			
Action	No further action required

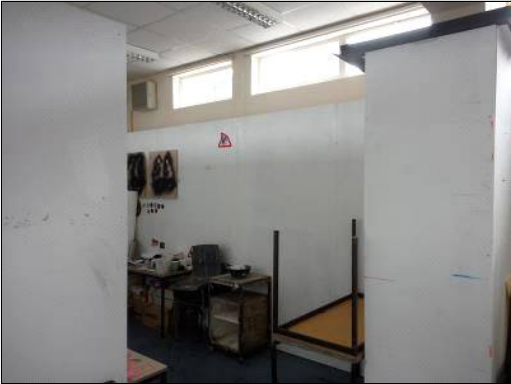
Assessment details				Comments	Photograph
Building	Administration Centre	Floor/ room	Ground Floor / 012 Art studio	Unable to access store cupboards due to timber partitions. Presumed to remain

Assessment no.	013	Accessibility	Usually inaccessible or unlikely to be disturbed		
Material Risk					
Identification	Presumed	Condition	Good Condition		
Extent	6m²	Asbestos Type	Crocidolite (or unknown)		
Location/ position	Insulating board Stores 1 and 2 ceiling panels				
Surface treatment	Surface Sealed				
Product type	Board				
Material risk	Low	Material risk score	6		
Action	Manage

The asbestos insulating board is a licensed asbestos product and its removal will require the services of a licensed asbestos contractor.

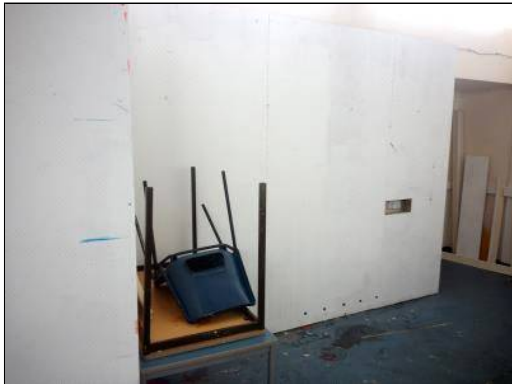
Assessment details				Comments	Photograph
Building	Administration Centre	Floor/ room	Ground Floor / 012 Art studio	Unable to access store cupboards due to timber partitions. Presumed to remain

Assessment no.	014	Accessibility			
Material Risk					
Identification	Strongly Presumed	Condition			
Extent		Asbestos Type	No Asbestos Detected		
Location/ position	Vinyl tiles Stores 1 and 2 floors				
Surface treatment					
Product type	n/a				
Material risk		Material risk score			
Action	No further action required

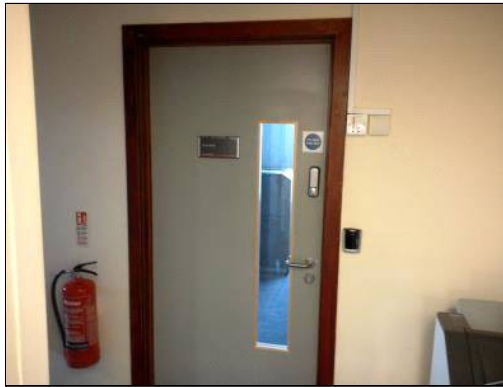
Assessment details				Comments	Photograph
Building	Administration Centre	Floor/ room	Ground Floor / 016 Data centre	No access - room alarmed, security escort required

Assessment no.	015	Accessibility			
Material Risk					
Identification	Inaccessible (Presumed)	Condition	n/a		
Extent		Asbestos Type	n/a		
Location/ position	No access				
Surface treatment	n/a				
Product type	n/a				
Material risk		Material risk score			
Action	Inspect Prior to Disturbance

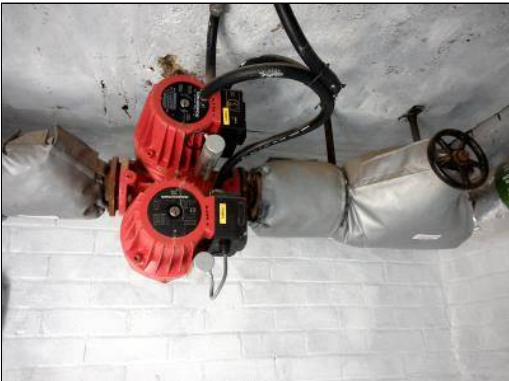
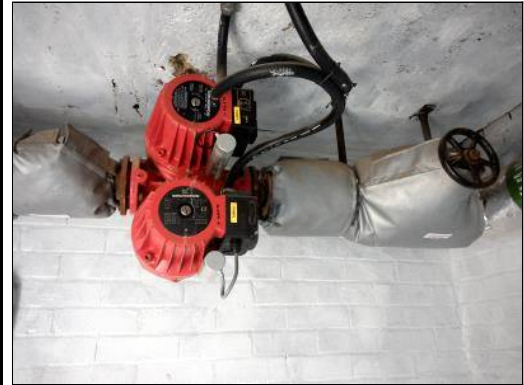
Building	Administration Centre	Floor/ room	Ground Floor / 018 Boiler room		
Assessment no.	016	Accessibility			
Material Risk					
Identification	Identified	Condition			
Extent		Asbestos Type	No Asbestos Detected		
Location/ position	Gaskets pipe flanges				
Surface treatment					
Product type	n/a				
Material risk		Material risk score			
Action	No further action required

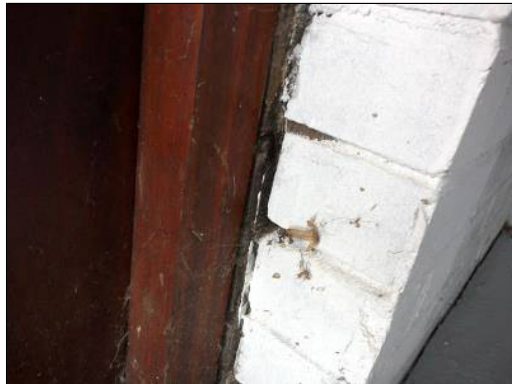
Assessment details				Comments	Photograph	
Building	Administration Centre	Floor/ room	Ground Floor / 018 Boiler room			
Assessment no.	017	Accessibility	Usually inaccessible or unlikely to be disturbed			
Material Risk

Identification	Identified	Condition	Good Condition			
Extent	6m²	Asbestos Type	Chrysotile			
Location/ position	Bitumen felt cavity wall lining					
Surface treatment	Completely Sealed					
Product type	Bitumen					
Material risk	Very low	Material risk score	2			
Action	Manage

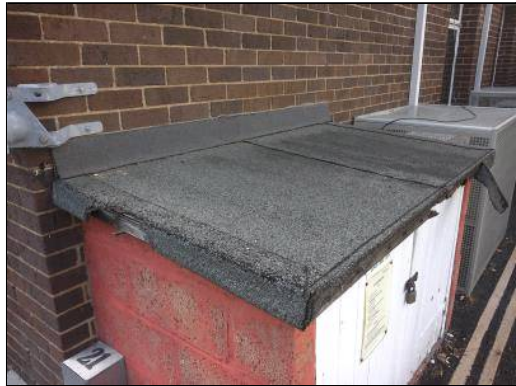
Building	Administration Centre	Floor/ room	External / Externals		
Assessment no.	018	Accessibility			
Material Risk					
Identification	Identified	Condition			
Extent		Asbestos Type	No Asbestos Detected		
Location/ position	Bitumen felt gas cupboard roof				
Surface treatment					
Product type	n/a				
Material risk		Material risk score			
Action	No further action required

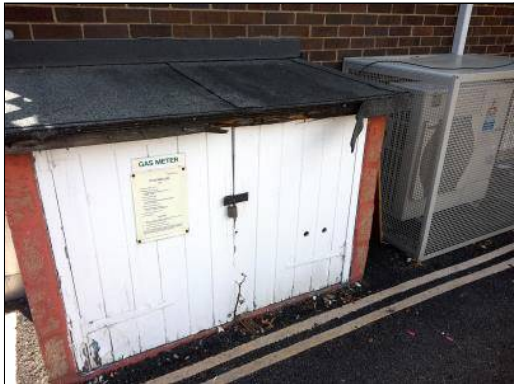
Assessment details				Comments	Photograph
Building	Administration Centre	Floor/ room	External / Externals	No access to gas meter cupboard - locked, no key available at time of survey

Assessment no.	019	Accessibility			
Material Risk					
Identification	Inaccessible (Presumed)	Condition	n/a		
Extent		Asbestos Type	n/a		
Location/ position	No access to gas meter cupboard				
Surface treatment	n/a				
Product type	n/a				
Material risk		Material risk score			
Action	Inspect Prior to Disturbance

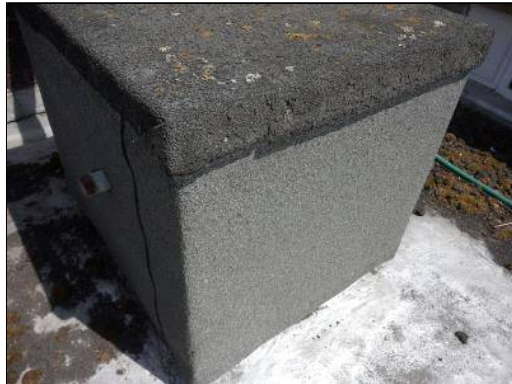
Building	Administration Centre	Floor/ room	External / Externals		
Assessment no.	020	Accessibility			
Material Risk					
Identification	Strongly Presumed	Condition			
Extent		Asbestos Type	No Asbestos Detected		
Location/ position	Bitumen felt Tank housing				
Surface treatment					
Product type	n/a				
Material risk		Material risk score			
Action	No further action required

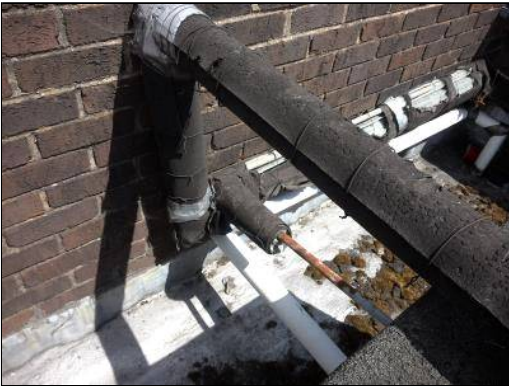
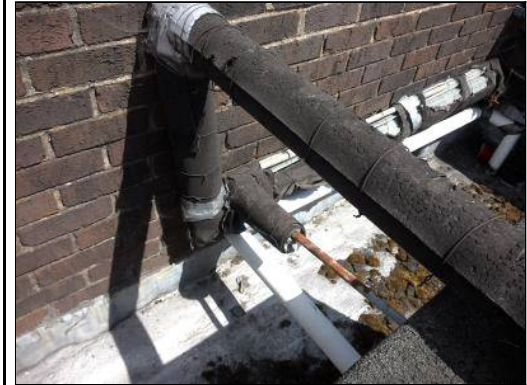
Building	Administration Centre	Floor/ room	External / Externals		
Assessment no.	021	Accessibility			
Material Risk					
Identification	Identified	Condition			
Extent		Asbestos Type	No Asbestos Detected		
Location/ position	Bitumen pipe wrap				
Surface treatment					
Product type	n/a				
Material risk		Material risk score			
Action	No further action required

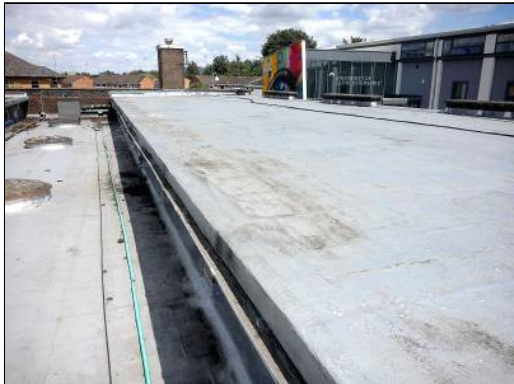
Building	Administration Centre	Floor/ room	External / Externals		
Assessment no.	022	Accessibility			
Material Risk					
Identification	Identified	Condition			
Extent		Asbestos Type	No Asbestos Detected		
Location/ position	Bitumen felt flat roof				
Surface treatment					
Product type	n/a				
Material risk		Material risk score			
Action	No further action required
